3174 Establishment Controller

GA27-3832-08

Status Codes

3174 Licensed Internal Code

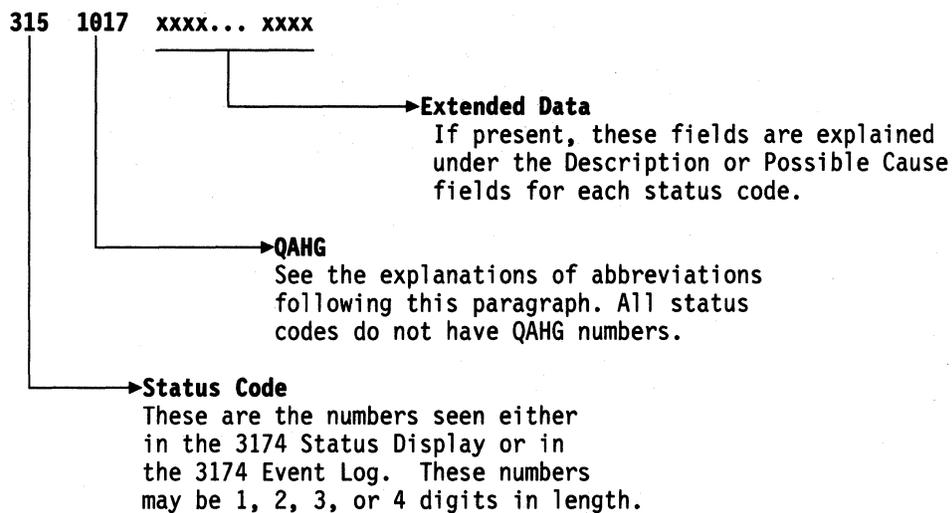
1. The base status code, qualifier (QA), hardware group (HG), and extended data (or additional fields) are shown on the first line of each status code entry in Status Code Charts that follow in this chapter.

For example:

In the Status Code Charts, *x* represents any number from 0 to 9.

- QA** Qualifier—A 2-digit number that immediately follows many of the base status codes. The base status code and the qualifier are both needed to identify a subsystem problem.
- HG** Hardware Group—A 2-digit number that follows the qualifier (QA) and represents a functional area of the controller. For example, a hardware group number 01 indicates *diskette drive 1*. A list of the hardware groups is shown in Figure 2-2 on page 2-18.
- B1B2...** Byte 1, Byte 2, and so on, of Extended Data field.
- LOCA** Location of the replaceable part (01 to 63).
- TYPE** Type number of the card. For example, 9154 is a type number of the File/Terminal Adapter. See Table 2-3 on page 2-15.
- Re-IML** To make the controller operational by pressing the IML (initial microcode¹ load) push button, or to obtain the 40 prompt by performing an ALT 1 IML.
